# Manhole Inspection Summary

Manhole # S17K1\_009MH

Insp Date: **4/30/08 1:06 PM**

**Location** Address: **3201 mardel av**

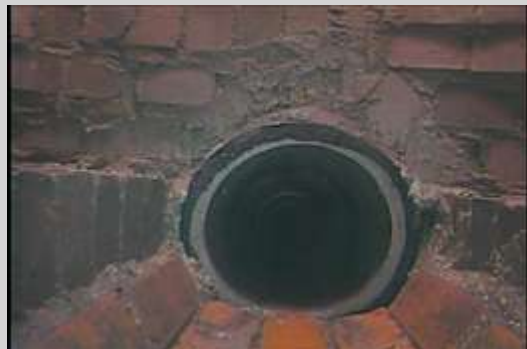
6 O'Clock Inflow

8 in. Circular Gravity Sewer  
Pipe In @ 6 O'Clock

Pipe Height: **8.4** (in.) Rod and Bar (Angled)

Pipe Material: **Clay** ☐ Pipe Lined

Infiltration: **None** Pipe Seal Cond: **Sound**
